Monthly Field Oversight Summary Report 2
ACS NPL Site
Griffith, Indiana
February 1, through March 2, 2001

BVSPC Project 46518
BVSPC File C.3
April 5, 2001

Subject: Monthly Oversight Summary Report
No. 2

Monthly Oversight Summary Report No. 2
ACS Superfund Site WA30, 46518.238

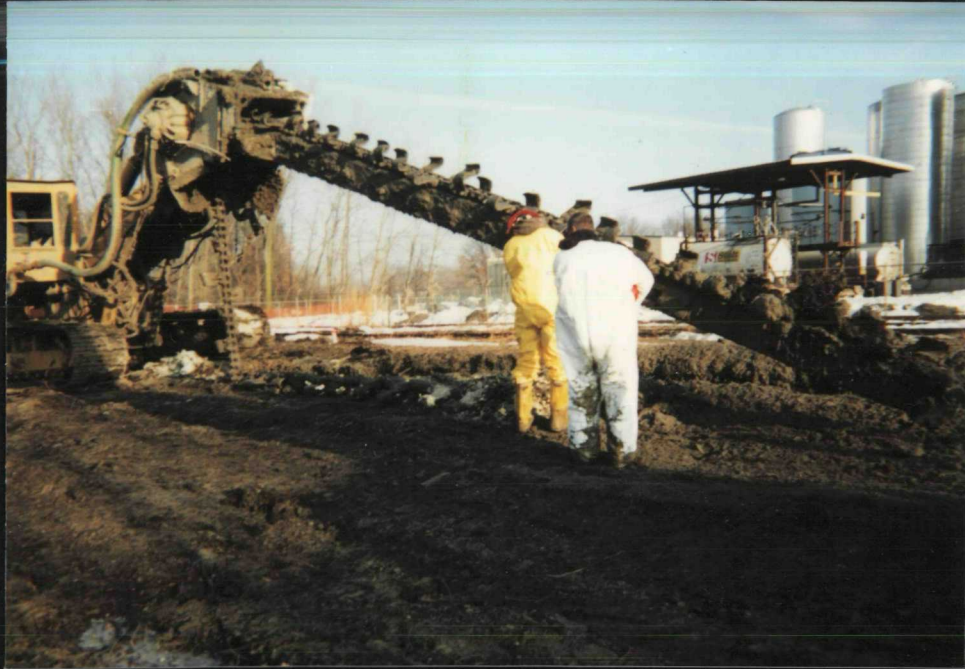
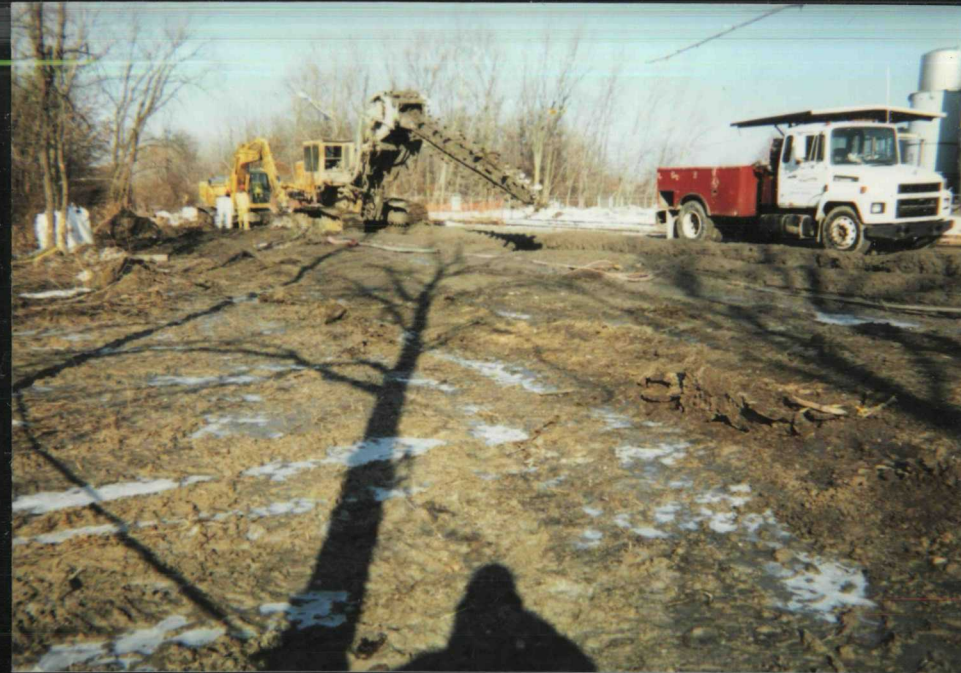
Site: American Chemical Services, Inc.
 Proj. #: 46518
 Roll: 1 Photo #: 7
 Date: 02-01-01 Time: 08:31
 Photographer: Chad Gailey
 Description: Photo facing west at the separation
 wall location 635 of Contract
 Dewatering repairing the trencher.

Site: American Chemical Services, Inc.
 Proj. #: 46518
 Roll: 1 Photo #: 8
 Date: 02-01-01 Time: 09:43
 Photographer: Chad Gailey
 Description: Photo facing west at the separation
 wall location 635 of Contract
 Dewatering repairing the trencher.

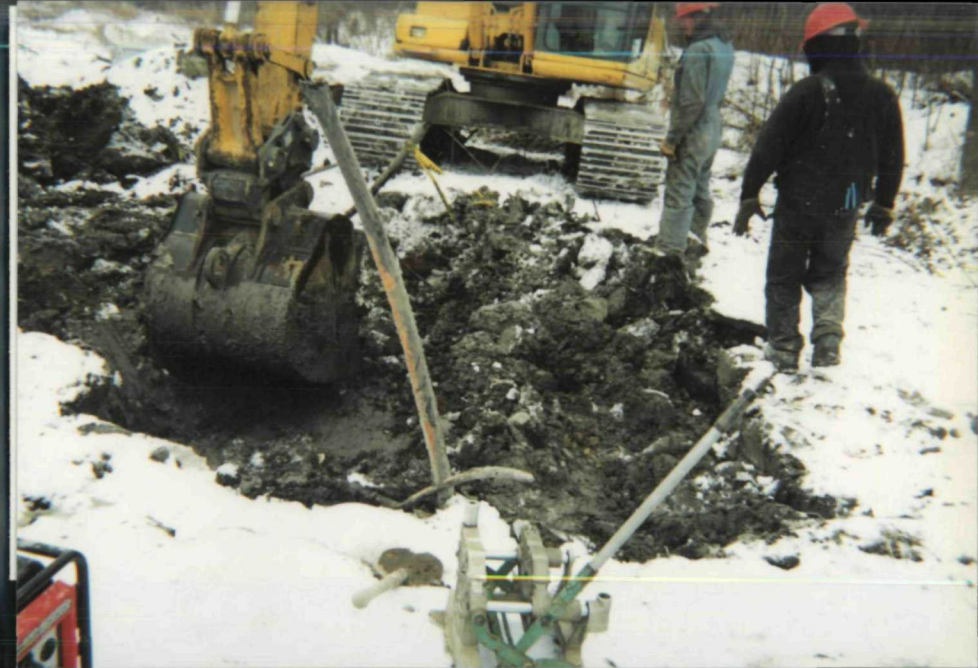
Description: Photo facing south at the offsite
area of CDS excavating to
reconnect existing piping damaged
during trenching activities.

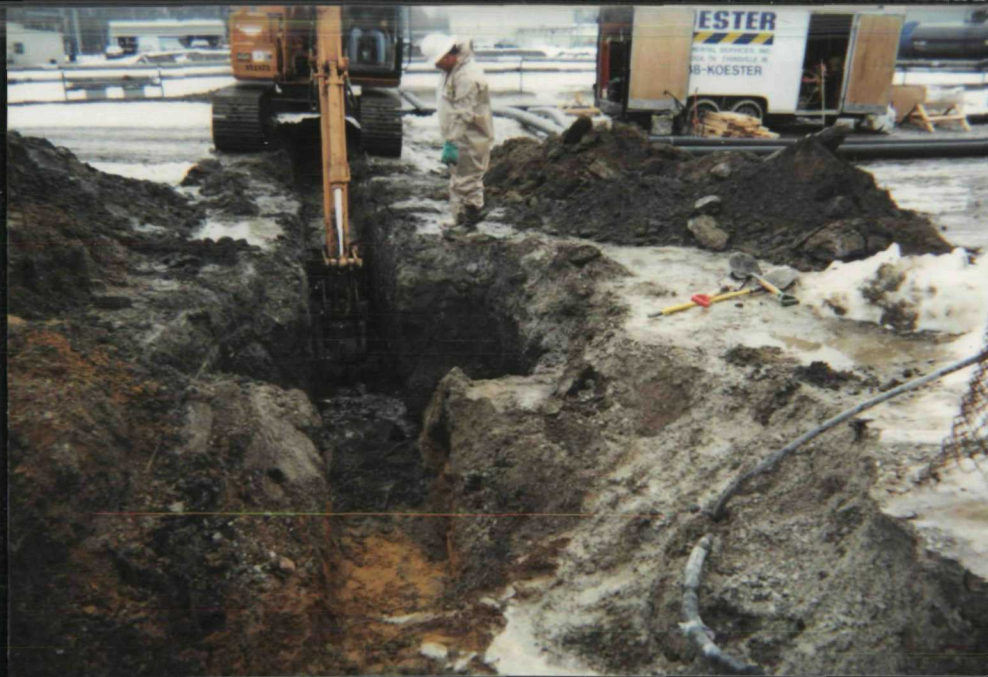
Site: American Chemical Services, Inc.
 Proj. #: 46518
 Roll: 1 Photo #: 19
 Date: 02-08-01 Time: 08:03
 Photographer: Chad Gailey
 Description: Photo facing east at water
 treatment plant of the excavation
 through the barrier wall by KES.

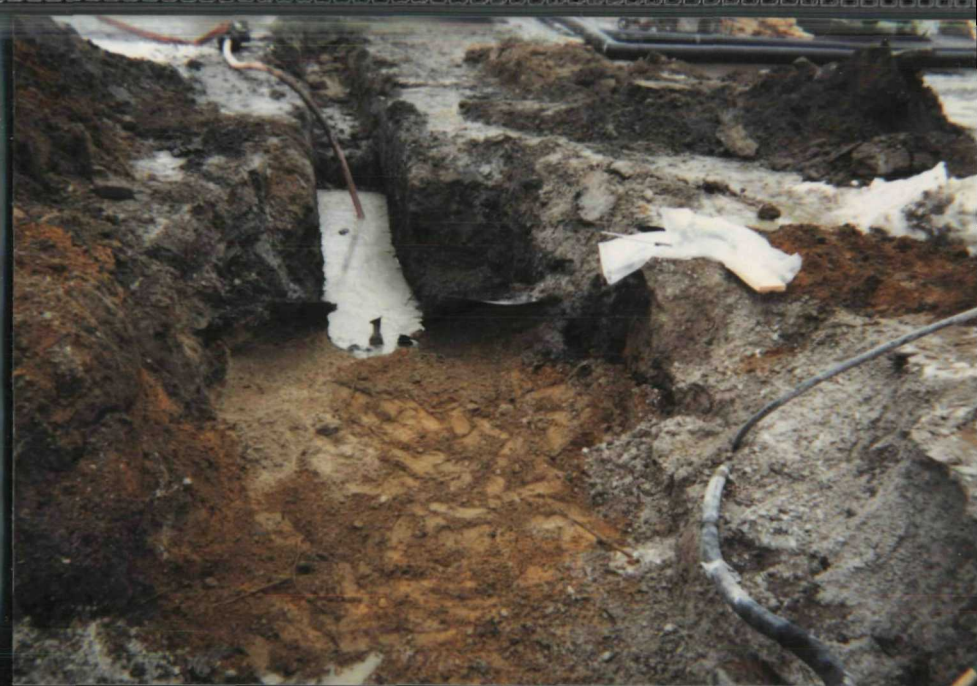
- Koester Environmental's penetration of the perimeter barrier wall has caused water leakage from the onsite area to the area next to the water treatment plant. BVSPC suggested a sump pump be installed to lower water level to prevent further leakage until the installation of the piping upgrade in this area is installed. Koester Environmental is performing periodic dewatering per Montgomery Watson's direction.

Site: American Chemical Services, Inc.
 Proj. #: 46518
 Roll: 1 Photo #: 20
 Date: 02-08-01 Time: 09:00
 Photographer: Chad Gailey
 Description: Photo facing east at water
 treatment plant of water seeping
 over the barrier wall.

8:59 KES, Has water from the onsite
hazwaste area leaking over slightly
on to the opposite side of the
Barrier wall.

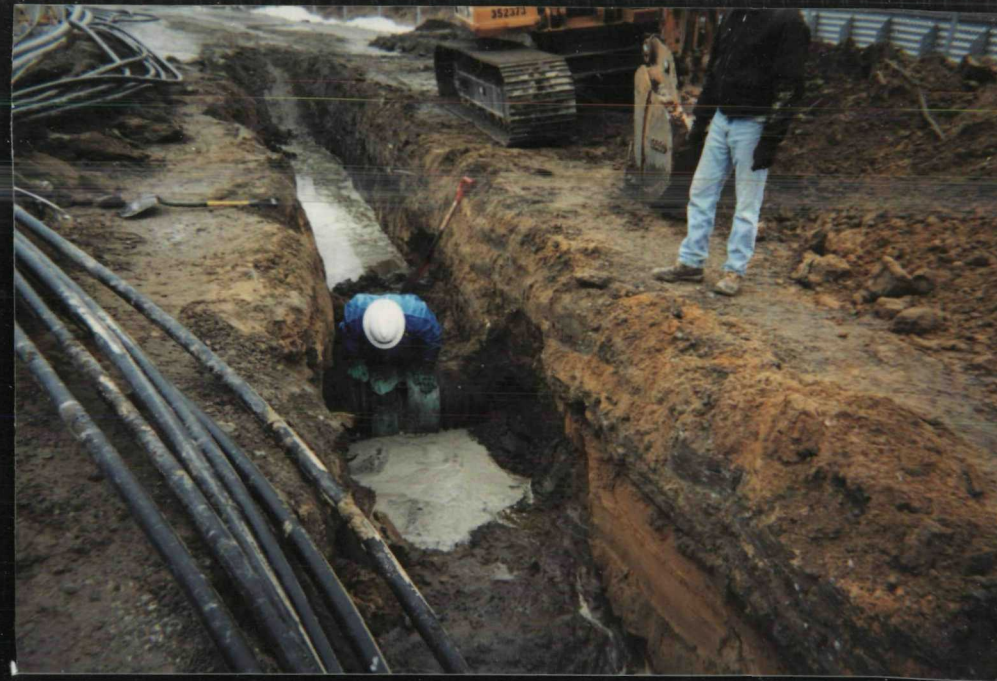
Site: American Chemical Services, Inc.
 Proj. #: 46518
 Roll: 2 Photo #: 5
 Date: 02-13-01 Time: 10:43
 Photographer: Chad Gailey
 Description: Photo facing south in the onsite
 area of KES repairing an ACS
 culvert hit during excavation.

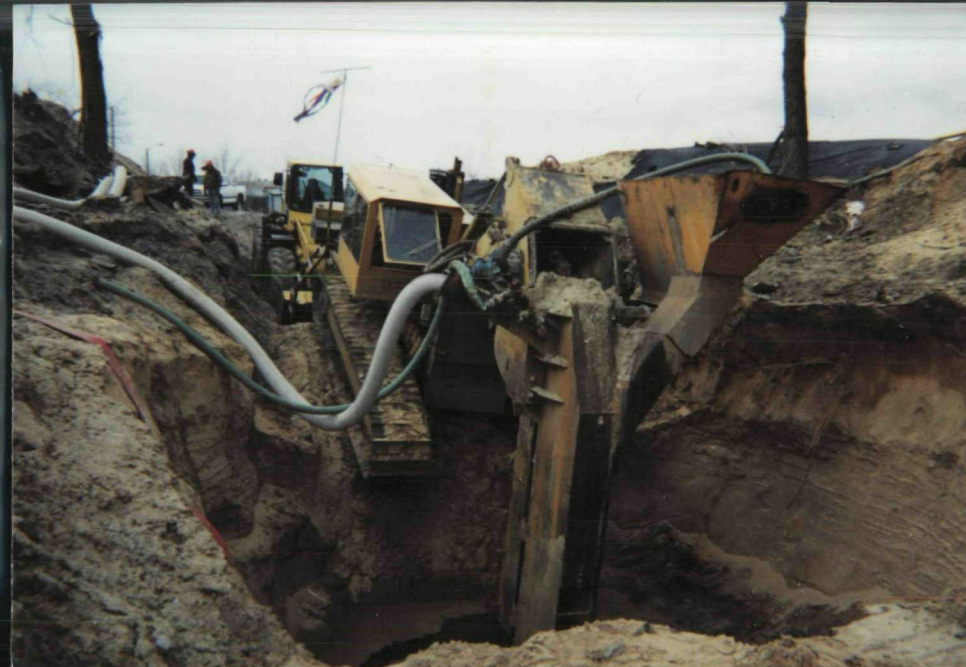
Description: Photo facing north at EW19 of CDS's trencher and it's precariously balanced stuck between EW19 and EW19A.

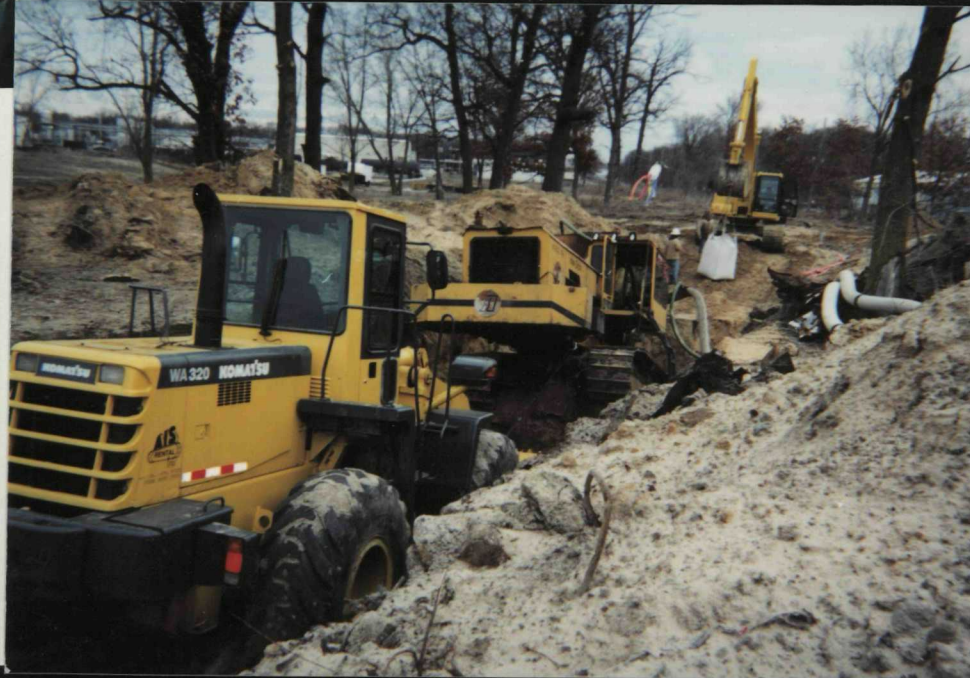
Site: American Chemical Services, Inc.
 Proj. #: 46518
 Roll: 4 Photo #:2
 Date: 02-27-01 Time:08:37
 Photographer: Chad Gailey
 Description: Photo facing south at EW19 of CDS's
 trencher and the loader acting as a counter
 balance.

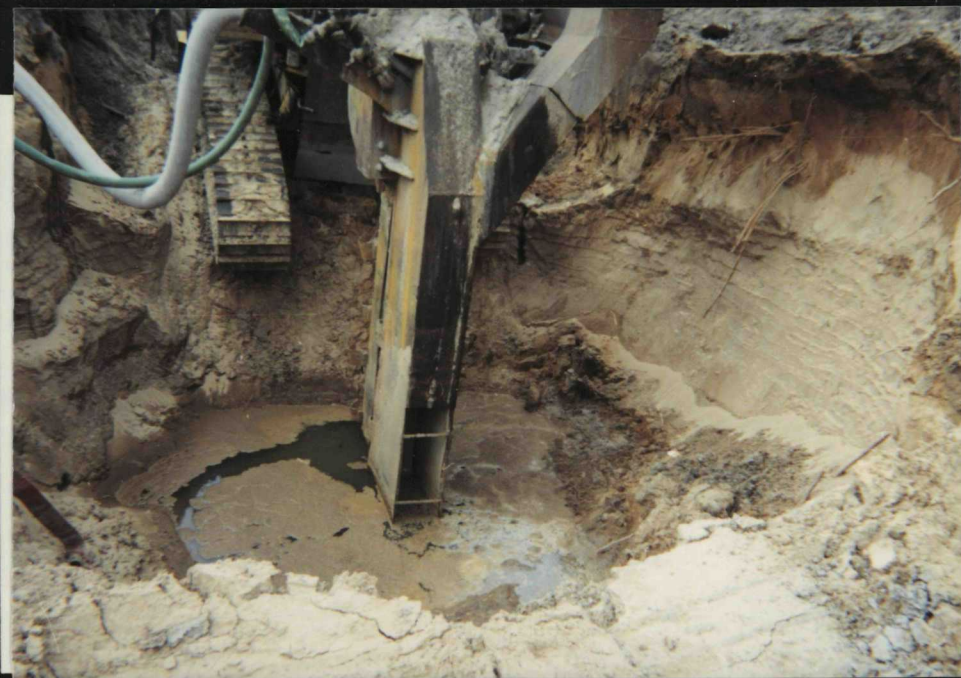
Site: American Chemical Services, Inc.
 Proj. #: 46518
 Roll: 4 Photo #: 3
 Date: 02-27-01 Time:08:40
 Photographer: Chad Gailey
 Description: Photo facing south at EW19 of CDS's
 trencher and the excavated hole to free the
 trencher.

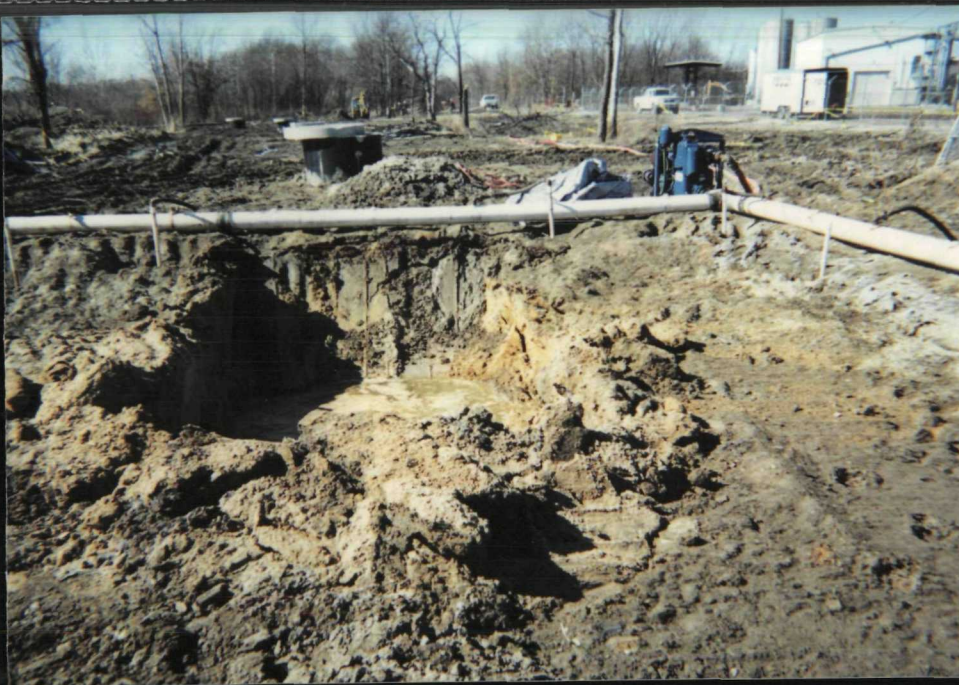
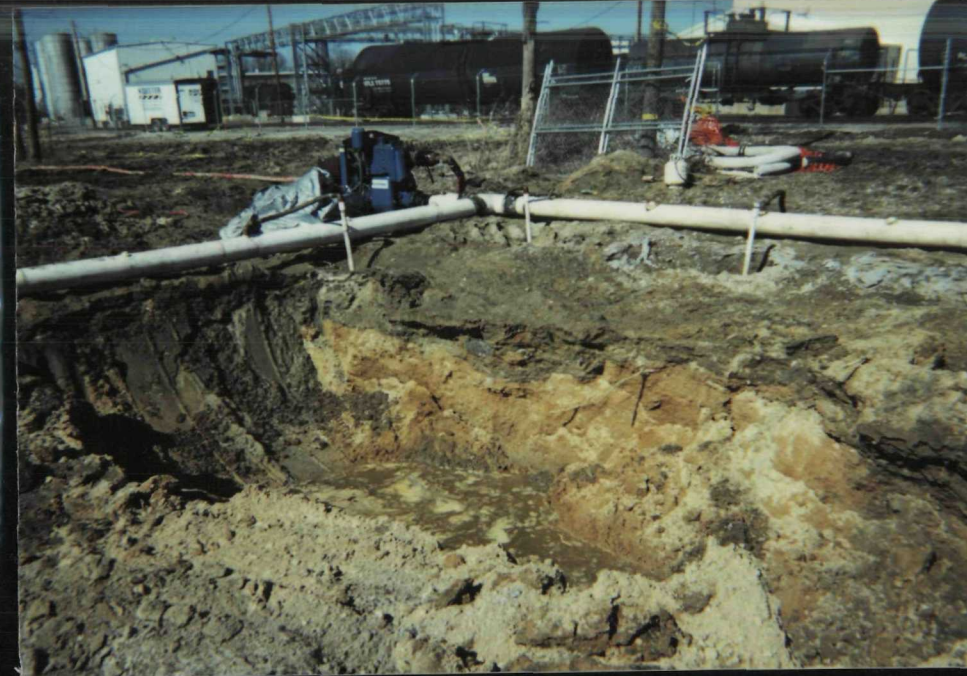
Clean out at EW20 was not recapture because localized de-watering was not possible. Contract Dewatering will attempt to recapture the clean out at a later date. This concludes Contract Dewatering Services activities.

Description: Photo facing west at the east end of EW20
of CDS's attempt to recapture the clean out
at EW20.
